Manhole Inspection Summary

Manhole # S45KK_029MH

Insp Date: **3/28/08 1:14 PM**

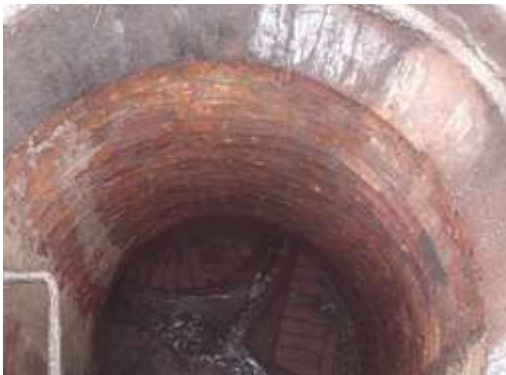
Defect 1

Adjustment Joint

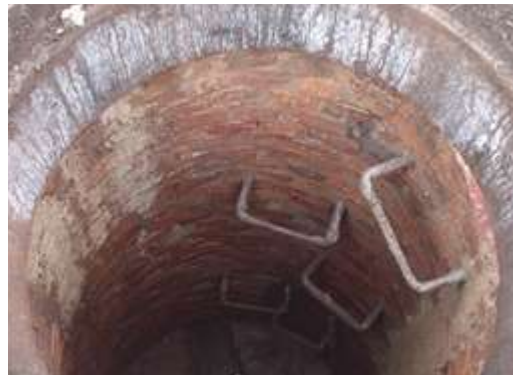
Defect 2

☒ **Leaks**

Frame Leaks

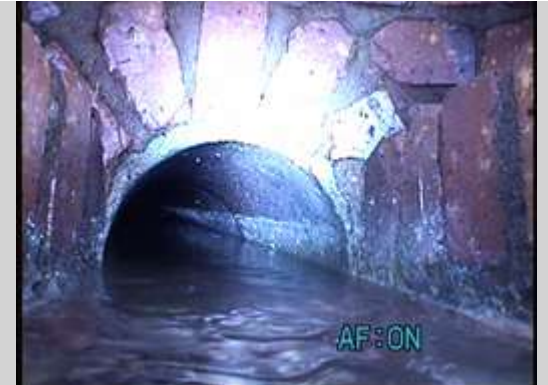
12 O'Clock Outflow

8 in. Circular Gravity Sewer
Pipe Out @ 12 O'Clock

Pipe Height: **8.4** (in.) Rod and Bar (Angled)
Pipe Material: **Clay** ☐ Pipe Lined
Invert Depth: **9.30** (ft.) Flow Characteristics: **Fast**
Deposits: ☐ None ☐ Mud ☒ Sludge ☒ Debris ☐ Grease
Silt Depth: **3** (in.) Deposits Extent: **Medium**
Infiltration: **None** Pipe Seal Cond: **Sound**

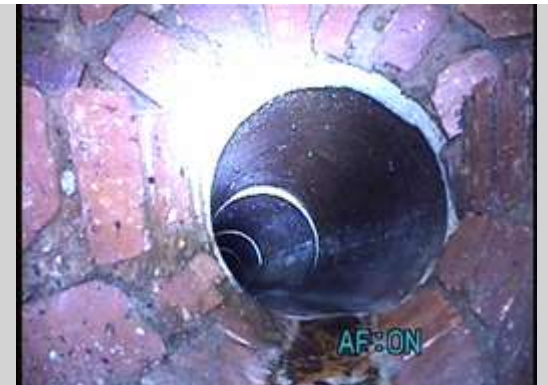
3 O'Clock Inflow

8 in. Circular Gravity Sewer
Pipe In @ 3 O'Clock

Pipe Height: **8.4** (in.) Rod and Bar (Angled)
Pipe Material: **Clay** ☐ Pipe Lined
Invert Depth: **8.80** (ft.) Flow Characteristics: **Fast**
Deposits: ☒ None ☐ Mud ☐ Sludge ☐ Debris ☐ Grease
Silt Depth: (in.) Deposits Extent:
Infiltration: **None** Pipe Seal Cond: **Sound**

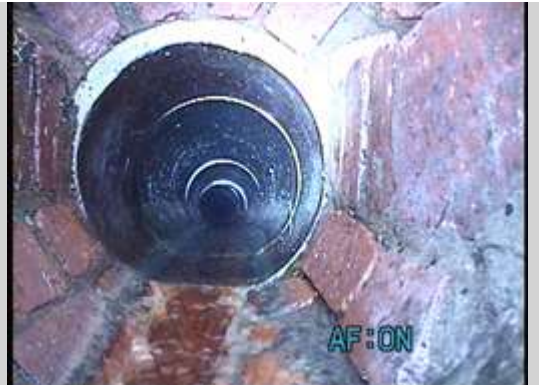
7 O'Clock Inflow

Pipe Height: **8.4** (in.) Rod and Bar (Angled)

Invert Depth: **8.70** (ft.) Flow Characteristics: **Fast**

Deposits: ☒ None ☐ Mud ☐ Sludge ☐ Debris ☐ Grease

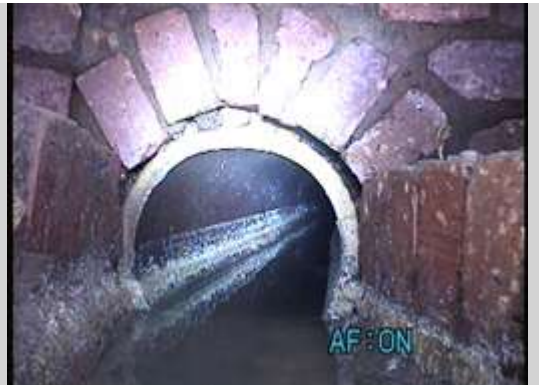
8 O'Clock Inflow

Invert Depth: **9.00** (ft.) Flow Characteristics: **None**

Deposits: ☐ None ☐ Mud ☒ Sludge ☒ Debris ☒ Grease

Silt Depth: **3** (in.) Deposits Extent: **Medium**
